Manhole Inspection Summary

Manhole # S45I__037MH

Insp Date: **10/31/08 9:50 AM**

Location Address: **1800 eastern ave**

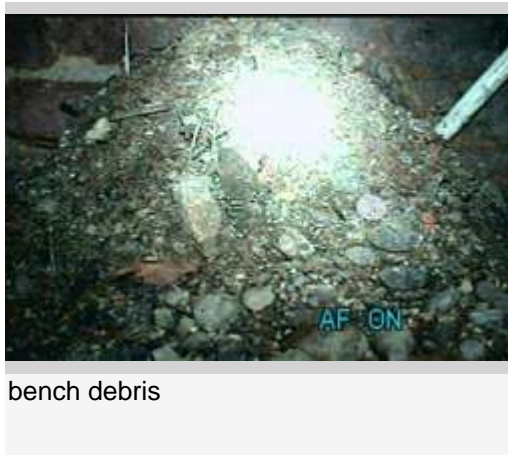
Defect 3

Condition: ☐ Sound ☐ Cracked ☐ Root Intrusion ☐ Deteriorated ☐ Leaks ☒ **Debris**

bench debris

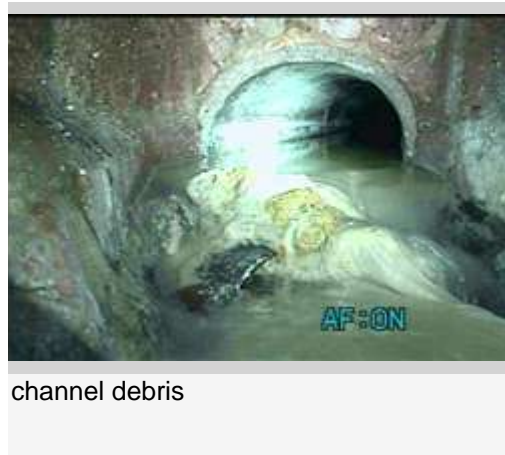
Defect 2

Condition: ☐ Sound ☐ Cracked ☐ Root Intrusion ☐ Deteriorated ☐ Leaks ☒ **Debris**

channel debris

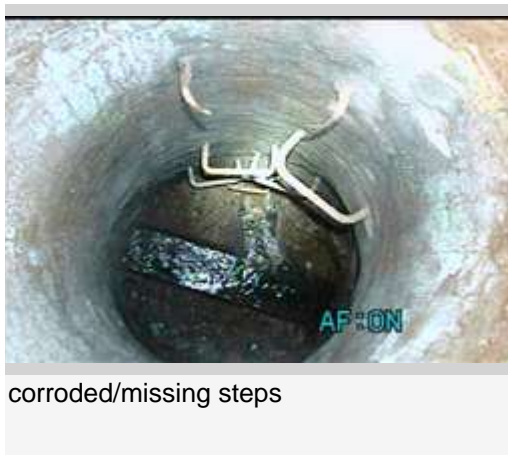
Defect 1

Count: **6** Missing: **1** ☒ **Corroded**

corroded/missing steps
